STEFFEN ROBERTSON AND KIRSTEN
Consulting Engineers and Scientists

Subject: Cricket Mountain Project (SRK#57705) - Response to UDOGM Comments on Notice of Intent to Revise Existing Large Mining Operation (M/027/006)

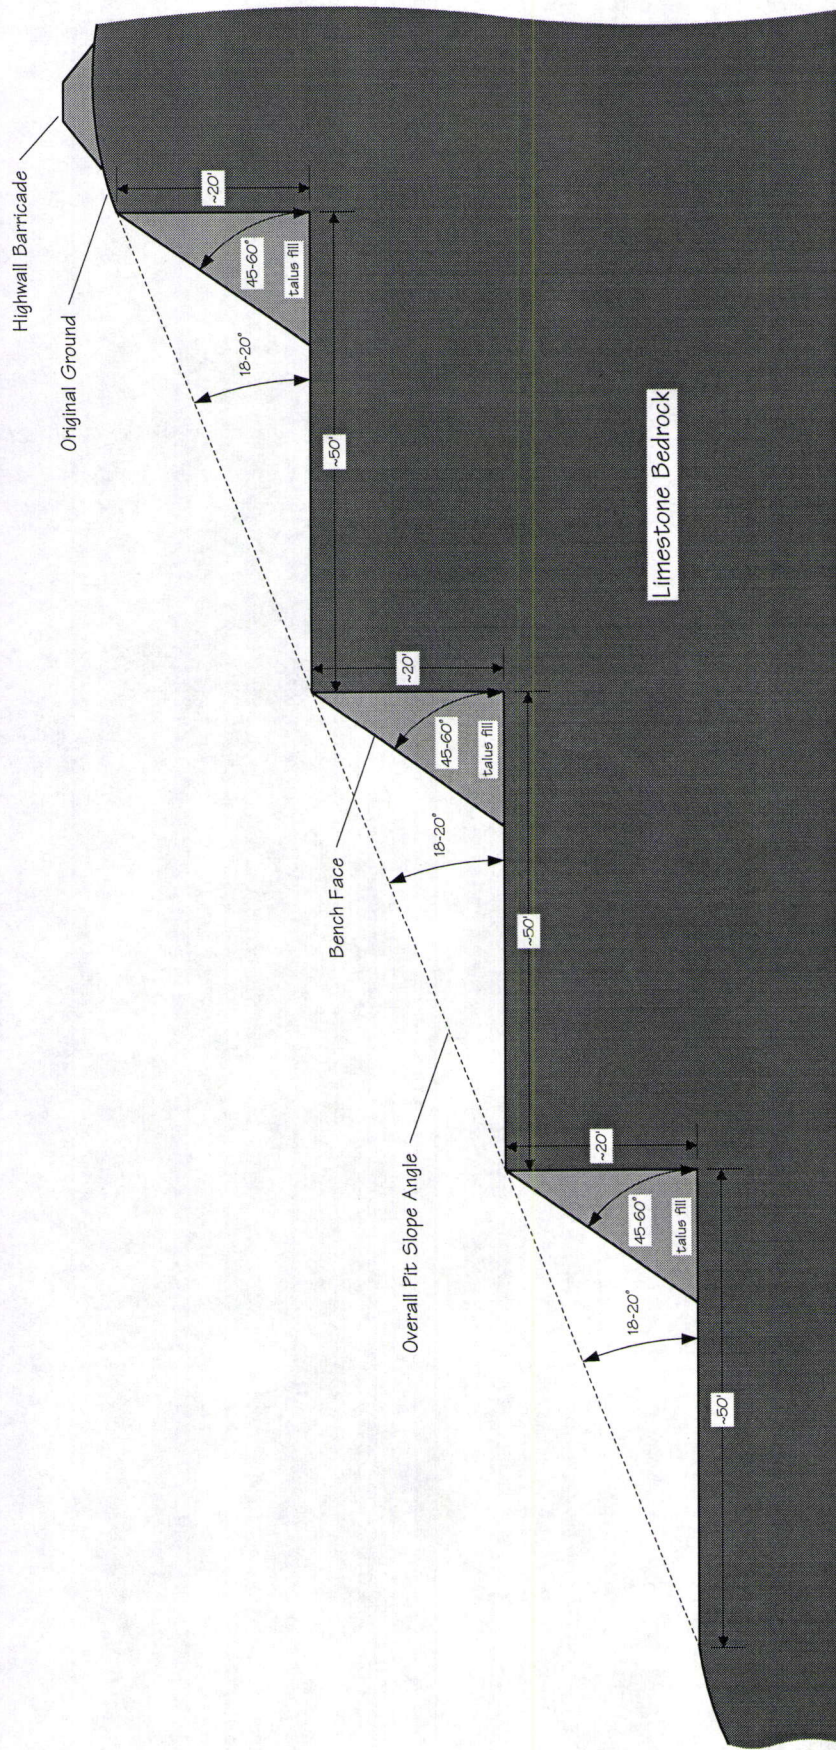
Figure B

Continental Lime, Inc
Cricket Mountain Project
Typical Quarry Cross-Section

The quarry walls will be developed parallel to the dip of the limestone beds with an overall slope of approximately 20°. The individual benches will be approximately 20 feet high and 50 to 60 feet wide. The initial inter-bench slope faces will be near vertical with slopes flattening over time through the natural development of talus fill to approximately 45 to 70° (see attached Figure B). This configuration will not produce high, long, steep slopes for the highwalls, but rather a more gentle stair-step configuration. This configuration, along with the proposed highwall barricade structures, will substantially limit the possible safety risks.
